Manhole Inspection Summary

Manhole # S15K__004MH

Location Address: **2569 lombard-emerson alley** Cross Street: **s franklintown rd**

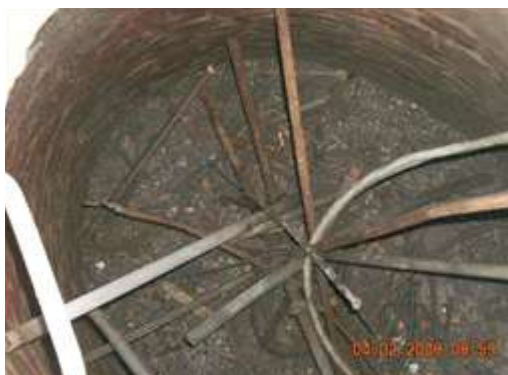
Defect 4

Condition: ☐ Sound ☐ Cracked ☐ Root Intrusion ☐ Deteriorated ☐ Leaks ☒ **Debris**

debris in terminal channel

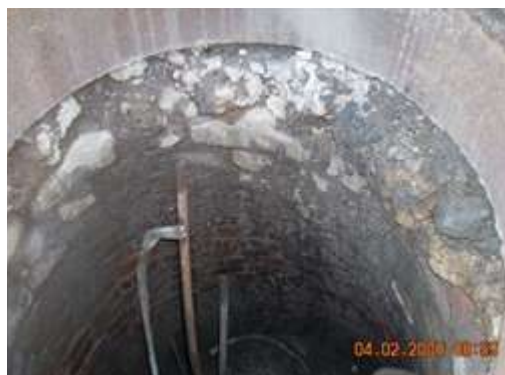
Defect 3

Infiltration: ☐ None ☒ **Joint** ☐ Cracks ☐ Mortar ☐ Roots ☐ Wall

infiltration @ chimney joint

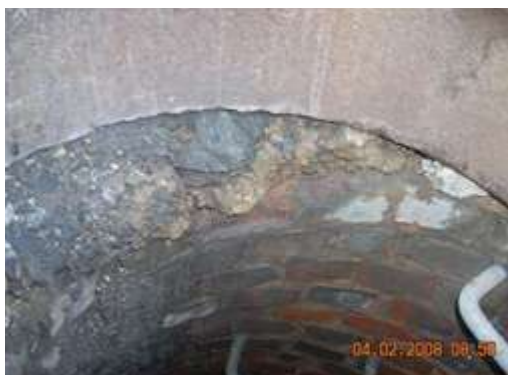
Defect 2

Condition: ☐ Sound ☐ Cracked ☐ Root Intrusion ☐ Loose Brick ☒ **Deteriorated**

deteriorated chimney

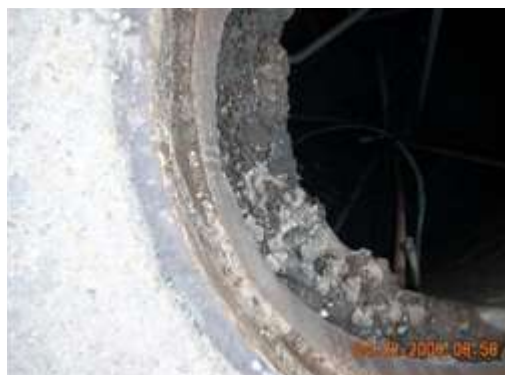
Defect 1

Frame Offset: **3** (in.) Condition: ☒ Sound ☐ Cracked ☐ Leaks

frame offset

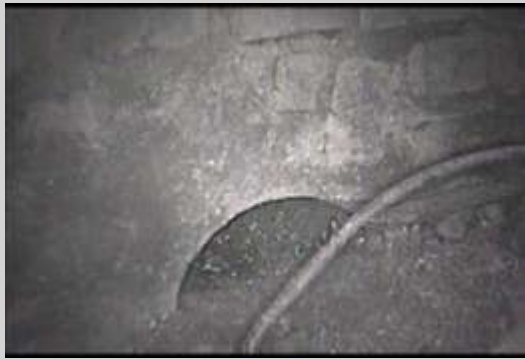
12 O'Clock Outflow

8 in. Circular Gravity Sewer
Pipe Out @ 12 O'Clock

Deposits: ☐ None ☒ **Mud** ☐ Sludge ☐ Debris ☐ Grease

Silt Depth: **6** (in.) Deposits Extent: **Heavy**
